# Lookout Creek Watershed Management Plan

A Local Stakeholder and Georgia EPD Approved Plan that Outlines the Framework for Improving Water Quality in Lookout Creek

<u>Prepared by:</u> Limestone Valley RC&D Council Daniel Huser Joshua Smith 105 Laurel Creek Road, Suite 6 Calhoun, GA 30701

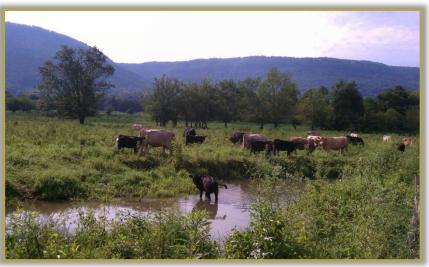
Figure 3.1.b. Cattle with direct access to streams can contribute to a high fecal coliform load, such as the loads found in lower Lookout Creek.

Sources of fecal coliform bacteria in streams include fecal contamination from humans, pets, livestock, and More specifically, wildlife. common causes of elevated fecal coliform counts in impaired rural watersheds include failing septic systems, livestock with direct stream access, applied manure, and natural areas with abundant wildlife. Relative proportions of contributors are watershed specific and hard to determine (as well as expensive).

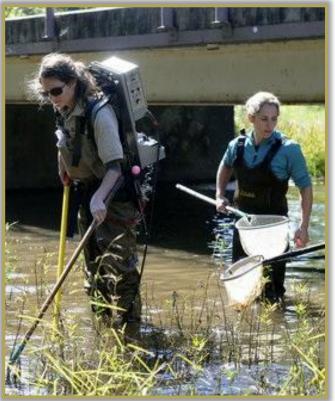
Figure 3.2.a. Fish sampling with backpack electrofishing equipment.

IBIs, according to Georgia EPD, assess the biotic integrity of aquatic communities based on the functional and compositional attributes of fish communities. They consist of twelve metrics, which assess species richness and composition, trophic composition and dynamics, and fish abundance and condition. Each metric is scored by comparing its value to that particular scoring criterion of the regional reference site. Collectively, the metric scores are combined to reach an IBI score that can be classified as Excellent, Good, Fair, Poor, or Very Poor.

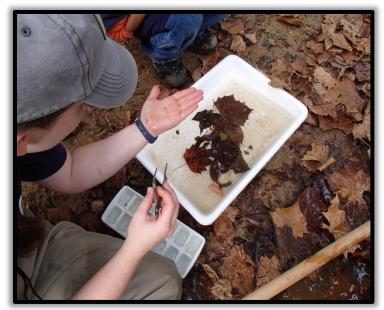
Figure 3.3.b. Limestone Valley Intern Amelia Atwell sorts macroinvertebrates for identification.

macroinvertebrate Results of the sampling efforts are shown in detail in the appendix. Overall, 55 families were collected including 11 intolerant families with at least one present at each site. Hurricane Creek had the greatest taxa richness (number of total families present) and was characterized as "very good". Otherwise, most of the tributaries within the watershed were characterized "good" according as to the macroinvertebrate biomonitoring data, with the exception of Gulf Creek, which was characterized as "poor", and Pope Creek, which was characterized as "inconclusive" and had the lowest taxa richness of any of the sites sampled.

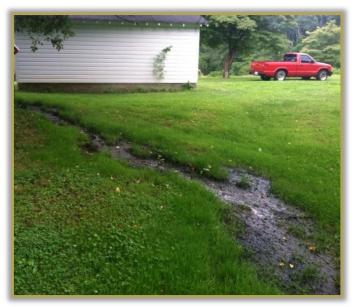
Figure 4.1.c. A failing septic system can introduce pathogens into nearby streams. This system has effluent surfacing in the yard, the vast majority of which drains into a nearby tributary.

With more than 5,000 septic systems in Dade County, stakeholders also identified failing septic systems as a probable contributor to the fecal coliform load in the watershed. Targeting these issues in the watershed should lead to water quality improvement, while also helping people in the community. It was decided by the stakeholder group that landowners experiencing septic system failures would likely be motivated to fix the issues, especially if cost-share assistance is available. Considering cost-share programs for septic system repairs have worked in other areas of Northwest Georgia, it seems this practice may again be implemented with success due to being seen as mutually beneficial to both members of the community and water quality improvement goals.

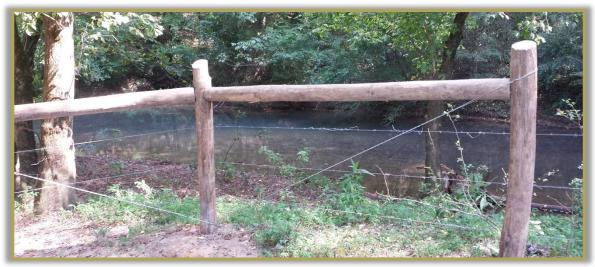
Figure 5.1.a. Excluding cattle from streams can reduce the fecal coliform load in the watershed.

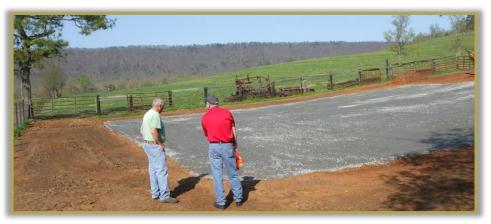
Figure 6.2.a. Constructing heavy use area pads for cattle feeding or watering areas can reduce erosion and sediment loads in the watershed.

Since agricultural activity encompasses a large proportion of land use within the watershed, the LCWRP will include a cost-share program that will help local farmers afford conservation practices that reduce fecal coliform and/or sediment contributions to receiving waters. Many of these practices are also beneficial to landowners which will serve as additional motivation for participation in the program. Most of the agricultural lands within the watershed are used for grazing, so funds need to be available to assist farmers with an interest in voluntary conservation to restrict livestock stream access and provide alternative watering sources. These practices would reduce the fecal coliform load from direct sources and agricultural runoff in the watershed. Projects that address erosion issues will likely include streambank and heavy use area stabilization.

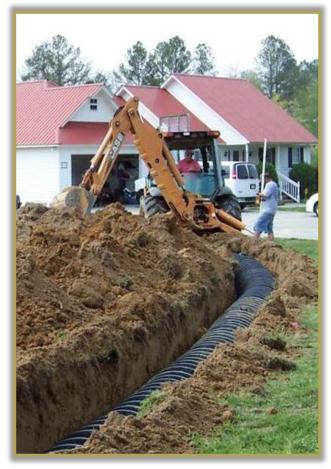
Figure 6.2.b. A septic system repair can reduce the fecal coliform load in streams. A cost-share program can help incentivize costly repairs.

The LCWRP will also include a cost-share program to address failing septic systems, since this issue was determined by the stakeholder group to be a significant contributor to the fecal coliform bacteria load in the watershed. High failure rates are said to occur for several reasons, including poorly percolating soils in some areas, outdated systems, and the low-income financial condition of a portion of the local population. A cost-share program in the area would help to incentivize more of the population to get their systems repaired. Cost-share rates are likely to vary according to the likely contributions of the failed systems to pollutant loads, and in the cases of impoverished families, financial conditions. In addition, greater public demand for septic system repairs will likely result in lower cost-
