# PINE LOG CREEK WATERSHED MANAGEMENT PLAN

A local stakeholder approved plan that outlines the framework for improving water quality in Pine Log Creek and its tributaries

Limestone Valley RC & D Council

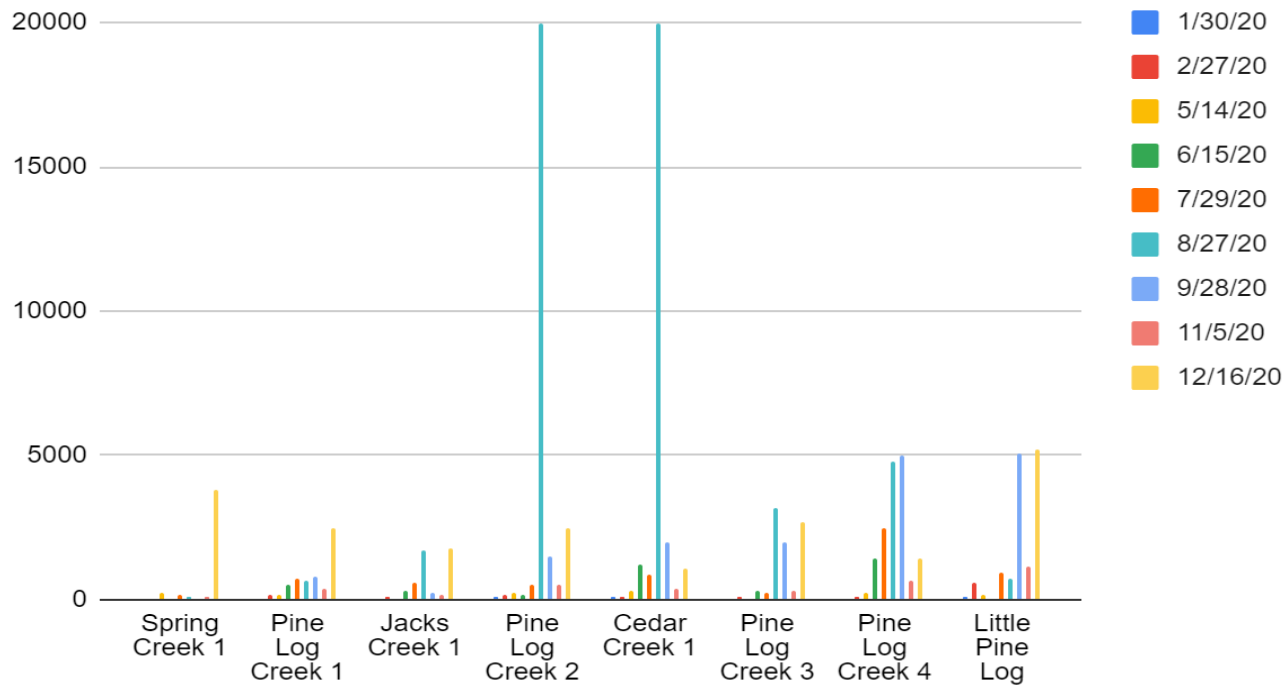
Figure 14. Fecal Coliform Data (CFU/100ml) Collected During the Planning Period

Fecal coliform appears chronically elevated above background conditions at all sites in the watershed. All sites approached or exceeded the non-human criteria for streams and rivers of 500 CFU/100 ml. This suggests widespread sources of fecal coliform in the watershed.

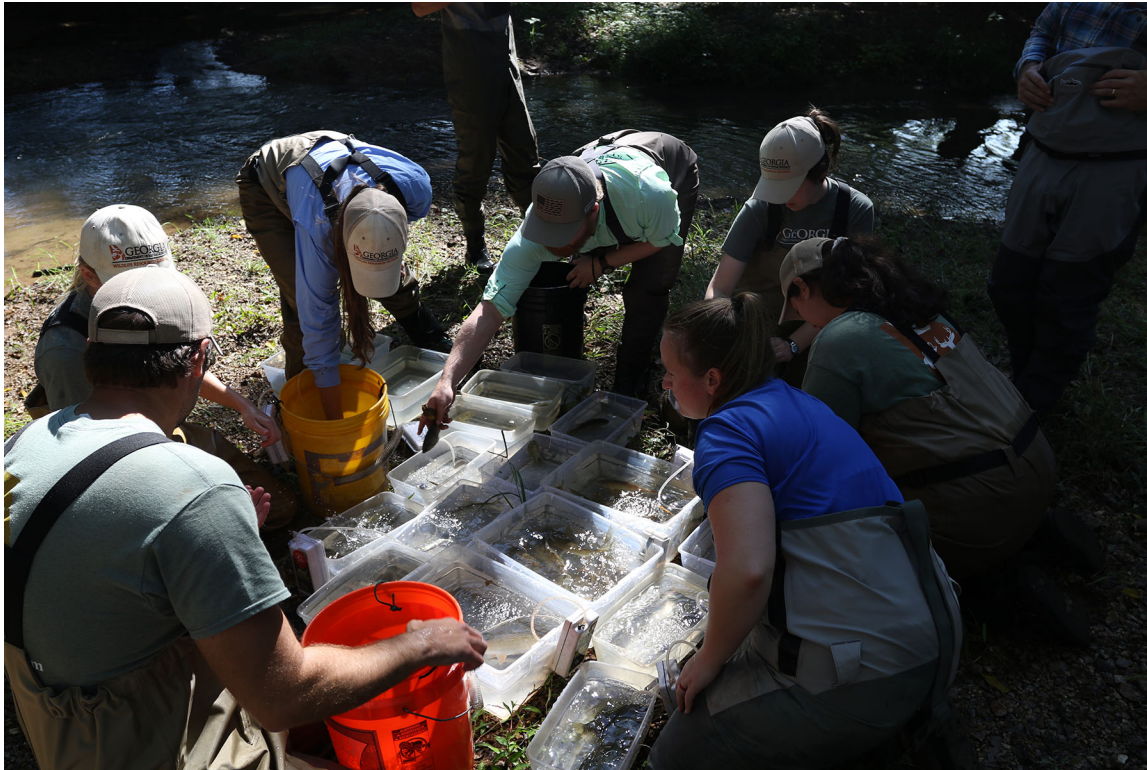
**Figure 3.** Sorting, identification, and enumeration of fishes during IBI study in Cedar Creek, GA, on 1 October 2020.

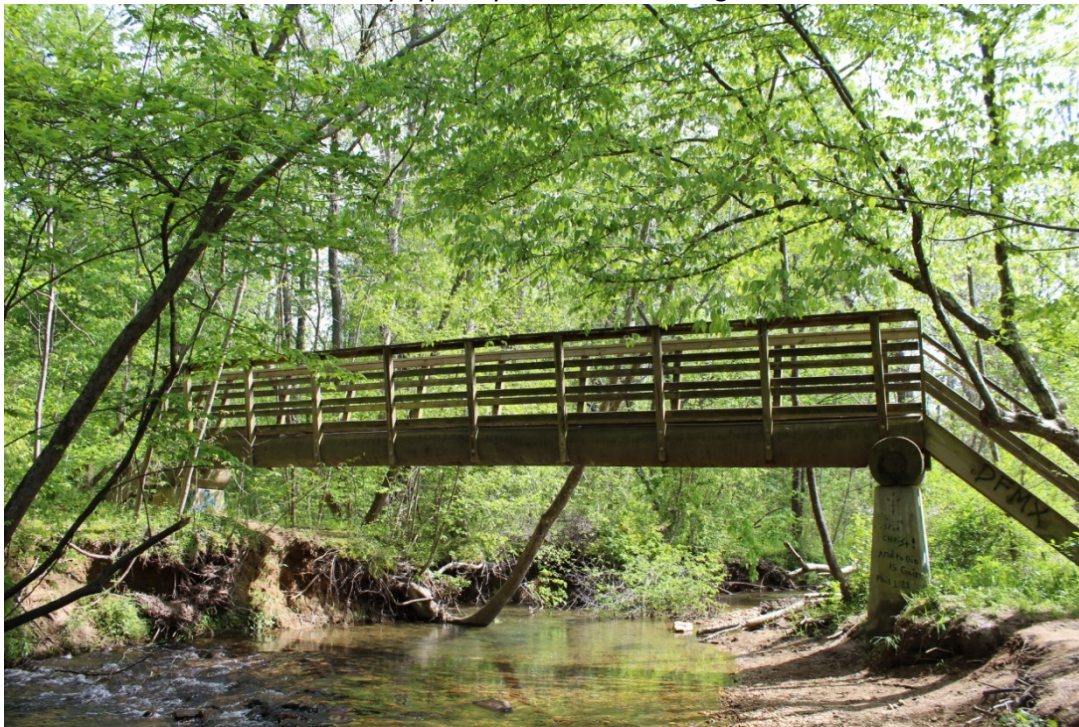
**Figure 4.** Pine Log Creek at trail crossing. Photo obtained from trail website at [https://www.bartowga.org/departments/pine\\_log\\_creek\\_walking\\_trail.php](https://www.bartowga.org/departments/pine_log_creek_walking_trail.php)

Pine Log Creek was the smallest site sampled in drainage area above the sample site (6.06 sq. miles) but had the second highest average stream width (5.7 m). The stream reach sampled for fishes in Pine Log Creek was 199.5 m long. This reach contained 3 pools, 6 riffles, and 1 bend. Stream width averaged 5.7 m, stream depth 0.20 m, and silt depth 3.4 cm. The majority of the sampled reach flowed through forest that was part of the Pine Log Creek trail managed by Bartow County, GA. Most of the shoreline had an extensive riparian zone. Bank erosion was evident near the trail crossing (see Figure 4). Water quality parameters are given in Table 4. It is noteworthy that the conductivity of upper Pine Log Creek (79  $\mu$ S, Table 4) was considerably lower than Cedar, Rock, or Jacks creeks (244.6-297.4  $\mu$ S, Tables 6, 8), indicative of the low conductivity typically found in Blue Ridge streams.
